Test report: Vapor line disinfection with Planet Strong at a leading German Dairy manufacturer

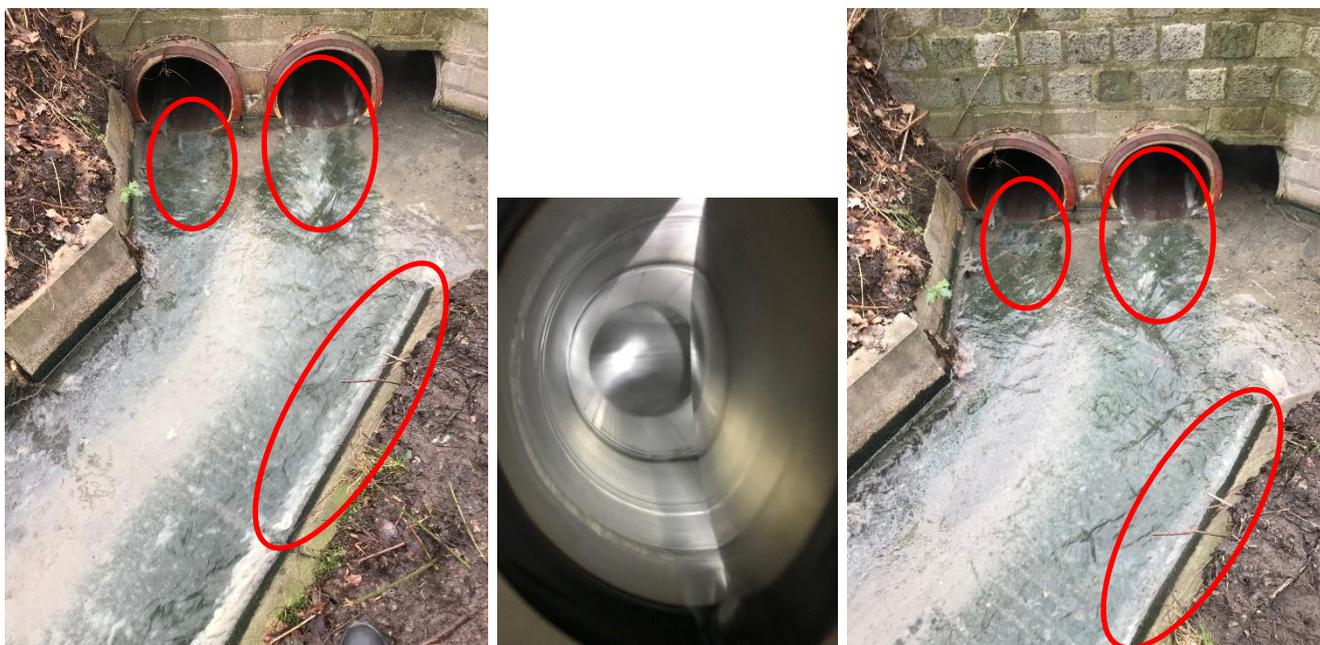
These pictures show the entrance to the trench at the beginning of the experiment on the left and a day later on the right. It can be seen that the deposits have decreased significantly, which I could also be seen in the pipeline to the boiler housing from drying 2. There has always been a very light, slimy coating, which is no longer present a day later, or has rebuilt.

- We then rinsed the dissolved biofilm out of the pipe system into the trench by 13:05, so that the disinfection can also work in the running pipe system. A decline and dissolve of biofilms was already visible. Deep yellow-brown to black biofilm clods kept flowing out of the pipe system, which speaks for a detachment and effect of the disinfectant.

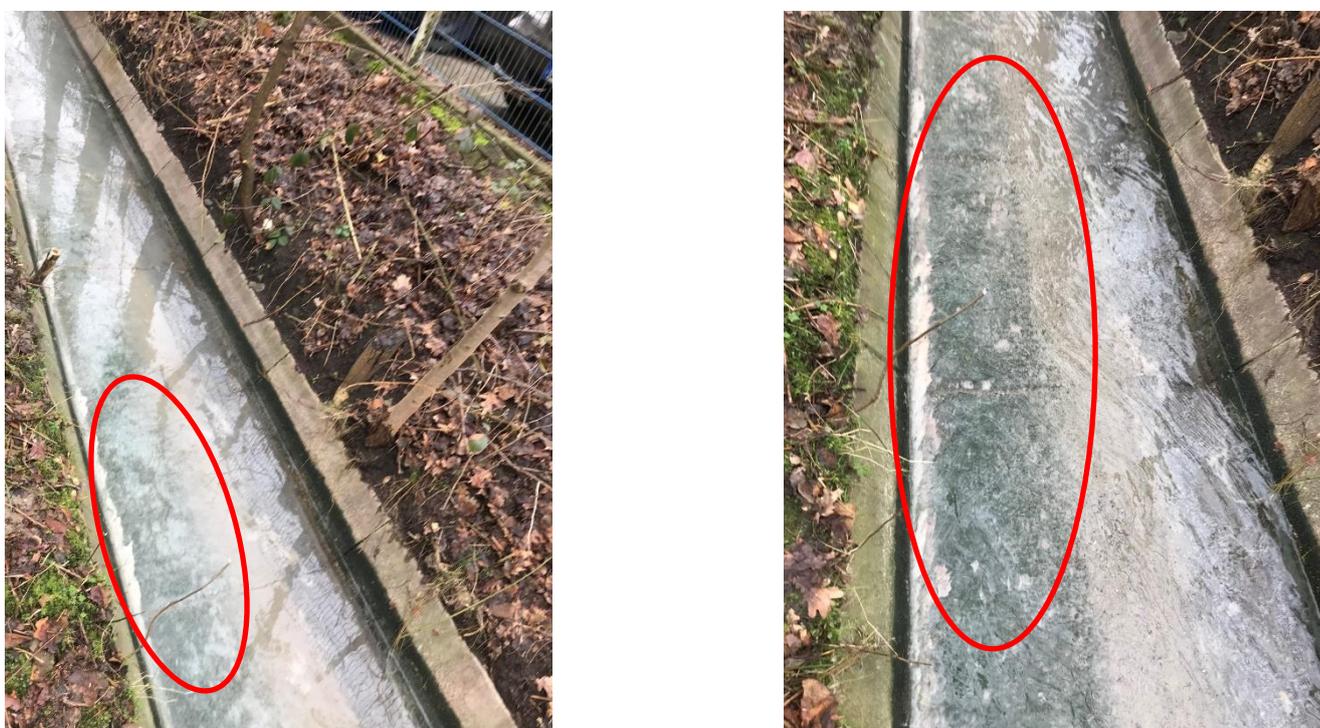
These two pictures also show an improvement in the situation due to the flushing process. How long this condition lasts has to be observed first.
